RELIABILITY ANALYSIS OF ROLLING BALL BEARINGS CONSIDERING THE BEARING RADIAL CLEARANCE AND OPERATING TEMPERATURE

Original scientific paper

The aim of the research conducted in this particular paper was related to a comprehensive reliability analysis of SKF 626 Open Deep Groove ball bearings, conducted under controlled laboratory conditions. The experimental research consisted of: measurements of radial internal clearance (RIC) in ball bearings, measurement methods for the detection of bearing operating temperature and rolling element bearing wear, complete with the cage deformation of the the damaged bearing, the failure of which was revealed after the examination. The inspected SKF 6206 open deep groove ball bearings operating under laboratory conditions – simulated the model of dynamic behavior under real conditions by using the crankshaft of an air compressor.

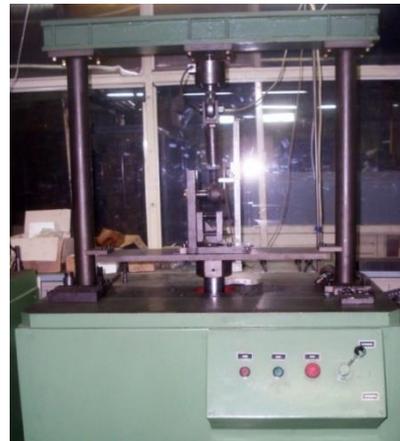
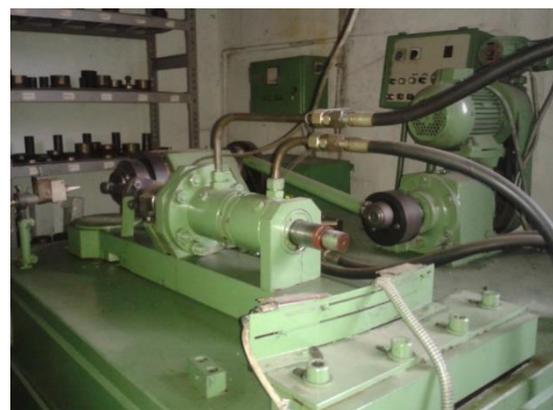
Figure 1. Layout of machine for testing axial and radial clearance

The rolling bearing test stand was constructed for the purpose of examination of rolling bearings with alternating loads, angular oscillation and rotation angle, with the parameters alternating according to the specific frequency. During the

examination, the process was run automatically, whereas the life cycle numbers were noted in each of the testing phases and in total as well. At the end of specific cycle phases, the measuring of output parameters was performed, primarily of axial and radial clearance complete with the bearing operating temperatures.

Laboratory testing of reliability of rolling bearings conducted at the rolling bearing test stand and by using dynamic and static load testing machines for rolling bearings measurements in the *Factory for the Manufacturing of Automobile Parts (FAD)*, Gornji Milanovac. The rolling bearing test stand developed by FAD, Gornji Milanovac, was constructed in the cooperation with the American company O&S in accordance with all the requirements necessary for testing of ball joints of type SAE 193 (Fig. 1a and 1b). The examination of reliability of rolling bearings was performed at the rolling bearing test stand (Fig. 1a and 1b).
