# EVALUATION OF CATHODIC PROTECTION SYSTEM FOR PIPELINES AT BREGA PETROLEUM MARKETING COMPANY IN LIBYA

Original scientific paper

The subject of the paper’s research is an oil plant for the transportation of oil derivatives located at the Brega company in Tobruk, Libya. This facility’s cathodic protection system is damaged, causing corrosion issues. Moreover, the “Arabian Gulf Oil Company” (AGOCO) facility, a new oil corporation, was built in the same vicinity, disrupting the current CP system and spanning the pipes. The research aimed to examine and analyze the existing CP pipeline system in the Brega

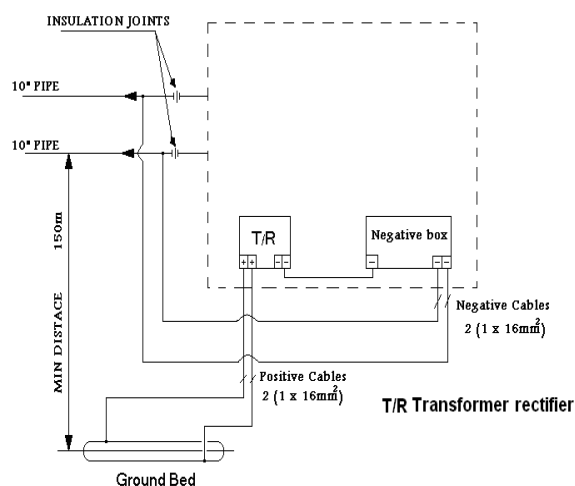
Fig. 1. CP system arrangement

The experimental work in the research was based on evaluating the CP system by following the schematic diagrams in Figs. 1 and 2. Fig. 1 explains the CP system arrangement for pipelines. Two CP systems are used to protect all areas of pipelines, as shown in Fig. 2. The hashed area presents the double CP system from the system at the Booster station (CPS1) and the Terminal station (CPS2).

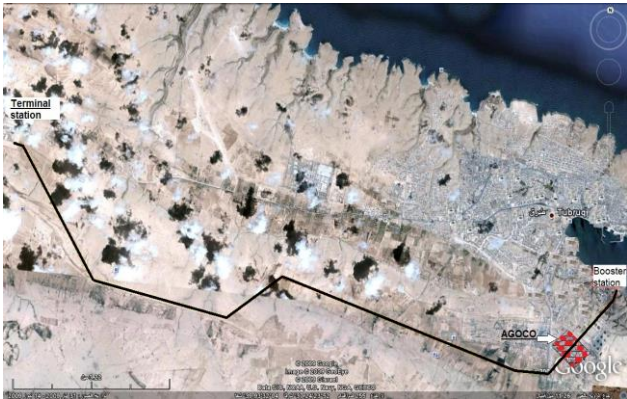
Fig. 3. Plane of Brega pipelines route from booster station to terminal station and AGOCO facilities

Fig. 3 shows the position of the AGOCO company as well as the pipelines that connect the (Booster station) to the (Terminal station) and the Brega company.

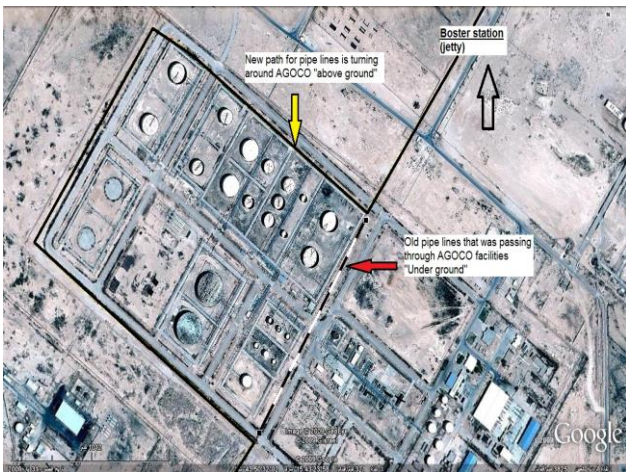
Fig. 4. More details on the Plane of intersection location between Brega pipelines and AGOCO facilities

An old pipeline route via AGOCO company is indicated by the red arrow in Fig. 4, which depicts the intersection of the pipeline with AGOCO (Arabian Gulf Oil Company) facilities.

Another solution to overcome this problem was bypassing the route around the AGOCO in order to avoid cross-linking between the two systems. Practically, this is done on upper ground, not underground.

The yellow arrow in Fig. 4 indicates the new path; the route of the pipes was modified so that the part of the path that passes under the AGOCO company was canceled, and the path in this part became above ground and revolved around the AGOCO’s facilities.

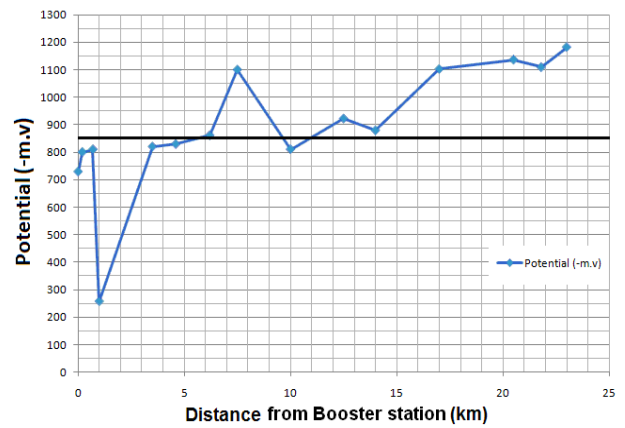
Fig. 5. The potential survey before linked with the AGOCO CP system

Due to the cross-linking of the AGOCO, as illustrated in Fig. 5, this circumstance damaged the CP system in the Brega company. Table 1 shows the output of transformer rectifiers in the cathodic protection systems. The extent to which

the interference with the AGOCO CP system impacted the Brega CP system was elucidated, and the potential was decreased by several points (Fig. 5), below the suggested potential difference (-850 mV). Point 4 (the intersection location) saw a severe drop in potential, and the pipelines there served as the AGOCO CP system’s anode.

One solution to this problem was connecting the two CP systems in this area at a suitable underground point to overcome this interference and keep the two systems running correctly. The potential survey after the connection is shown in Fig. 6, and the output of transformer rectifiers of cathodic protection systems used is obtained in Table 2. The potential value of all tested points is higher than that recommended by the manufacturer company. However, that solution cannot be maintained due to technical problems at AGOCO company.

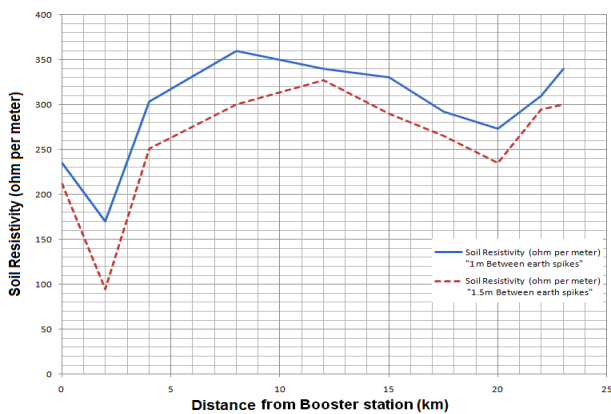
Fig. 7. Soil resistivity along the route of pipelines

Fig. 7 explains the soil resistivity measured along the pipeline's placement. The soil resistivity drops in the booster station's direction, reaching its lowest value near the junction of AGOCO and Brega pipelines. This is a result of the damp ground close to the ocean.

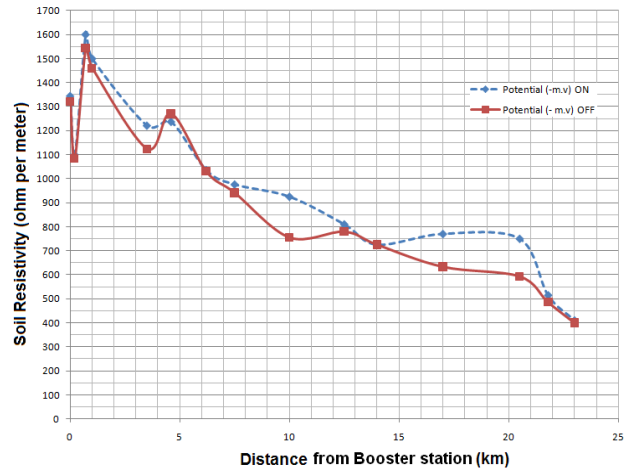
Fig. 8. Change in the potential difference between turn on and turn off of the CP system

The potential survey along the pipelines measured is shown in Fig. 8, and the output of transformer rectifiers of cathodic protection systems used is obtained in Table 3. Almost there is no change in the potential difference between the application of cathodic protection systems (turn on) and without application of it (turn off).

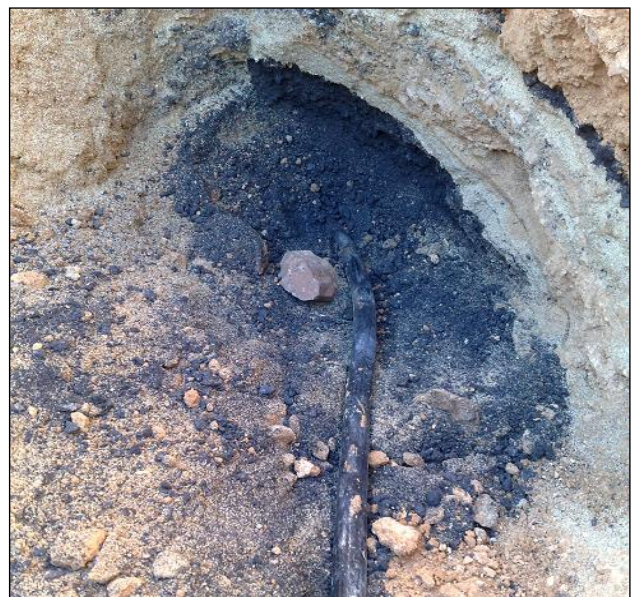
Fig. 9. Consumed anode ground bed in Brega CP system

This is attributed to anode decay in different locations because of the ending of its time life of 5 years, as shown in Fig. 9. So, the AGOCO CP system is still affected by Brega pipelines; this is quite clear from the potential value near the Booster station.

It is recommended that the cathodic protection system be analyzed in detail for a successful evaluation of the CP system for oil transportation. To ensure further reliable operation, the blocked anodes must be replaced, and the rectifier must be maintained comprehensively. To ensure the sustainability of cleaner generation systems, a careful monitoring system must be implemented that considers both excess and decreased potential.
