INVESTIGATION OF THE CAUSES OF THE FRACTURE OF THE DRIVE SHAFT OF THE ELECTRIC LOCOMOTIVE

Original scientific paper

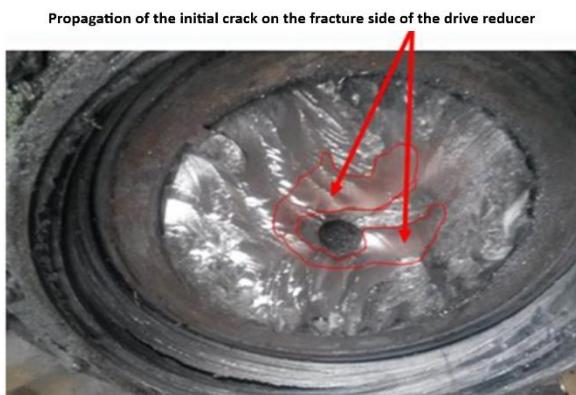
Fig. 7. Propagation of the initial crack in the shaft, position on the side of the resulting fracture to the reduction gear

Given that the material of the locomotive's driving shaft is improved and has high strength and toughness, it has the characteristic of withstanding high static and dynamic loads. The fine-grain structure of the material clearly indicates that the propagation of the initial crack due to combined loading is an inevitable mechanical process. The crack propagation zone is very smooth (roughness at the level of crystal grains), as shown in Figs. 7 and 8.
