# COMPARISON OF REINFORCEMENT METHODS WITH ADVANCED MATERIALS FOR R/C COLUMNS

Original scientific paper

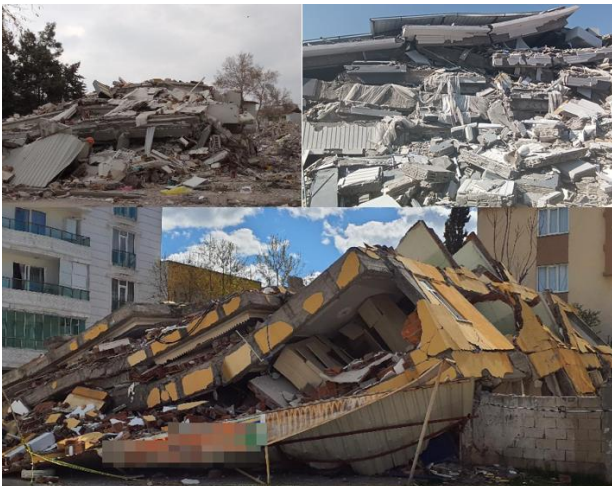
Earthquakes can weaken, damage, or even cause the complete collapse of structures by generating forces from ground movements. The severity of the earthquake, local soil conditions, and the characteristics of the buildings directly affect the extent of the damage that occurs in a structure. The engineering properties of the existing building stock in areas affected by earthquakes, along with the adherence of structures to earthquake-resistant design principles, are the most important factors determining their durability and response to earthquakes. Therefore, proper design and construction practices ensure that buildings sustain less damage during an earthquake. The earthquakes that occurred on February 6, 2023, in Kahramanmaraş, were a major disaster affecting south-eastern Turkey. The earthquake pair, with epicentres in the Pazarcık and Elbistan districts of Kahramanmaraş, caused massive destruction and loss of life in 11 different provinces. With magnitudes of  $M_w=7.7$  and  $M_w=7.6$ , the earthquakes occurred on the same day and in the same region, and aftershocks significantly amplified the destruction, making interventions in damaged buildings more difficult. The earthquakes caused severe destruction, particularly in provinces such as Kahramanmaraş, Hatay, Adıyaman, and Gaziantep, resulting in extensive damage to many buildings. Reinforced concrete structures, which dominate the urban building stock, were one of the main types of buildings affected by these large earthquakes. Examples of totally collapsed RC buildings are shown in Fig. 1.

**Fig. 1.** Totally collapsed R/C buildings.

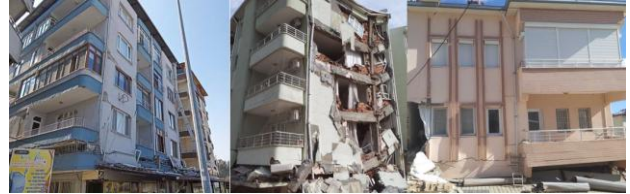
One of the major causes of damage in RC buildings is soft/weak story damage caused by differences in stiffness and strength between stories. Such stories generally cause the structure to be unbalanced in terms of story mass and story rigidity [41-44]. In this case, total or partial collapses may occur in the stories with differences. Examples of such failure are illustrated in Fig. 2.

**Fig. 2.** Examples of damages caused by soft/weak story

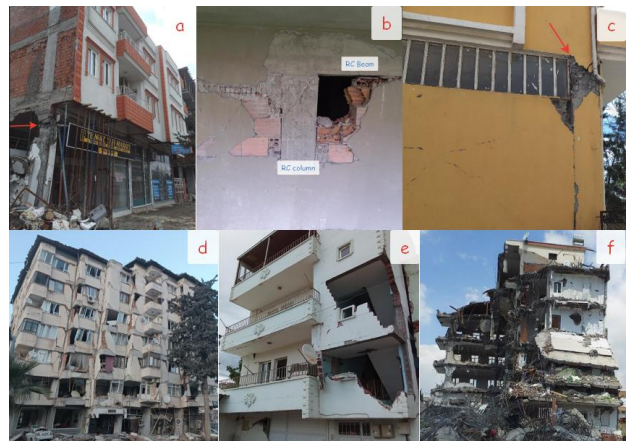
In RC buildings, different levels of damage have been observed as a consequence of irregularities and negativities that affect earthquake performance. Examples of such damage are shown in Fig. 3.

**Fig. 3.** Structural damages caused by different structural negativities a) pounding effect, b) strong beam-weak column, c) short column, d) irregularity in plan, e) heavy overhang, f) lack of RC frame

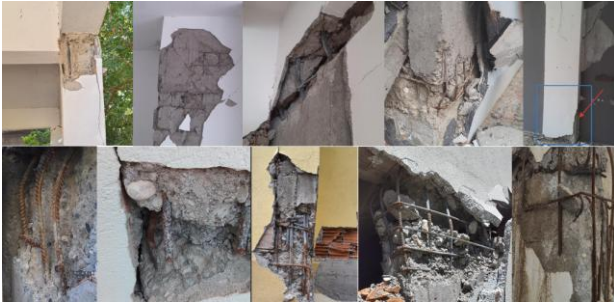
The usage of low-strength concrete and insufficient transverse reinforcement in reinforced-concrete (RC) load-bearing elements, the lack or incorrect interlocking between the reinforcements, insufficient concrete cover thickness, corrosion of the reinforcements, inappropriate aggregate gradation, and the installation of different utility elements in load-bearing components have particularly caused significant damage to RC columns. For these reasons, examples of damage that occurred in RC columns are shown in Fig. 4. The presence of one or more of these negativities together has reduced the bearing capacity of R/C columns, causing the damage levels to rise to a higher level.

**Fig. 4.** Examples of damage to RC columns due to different reasons

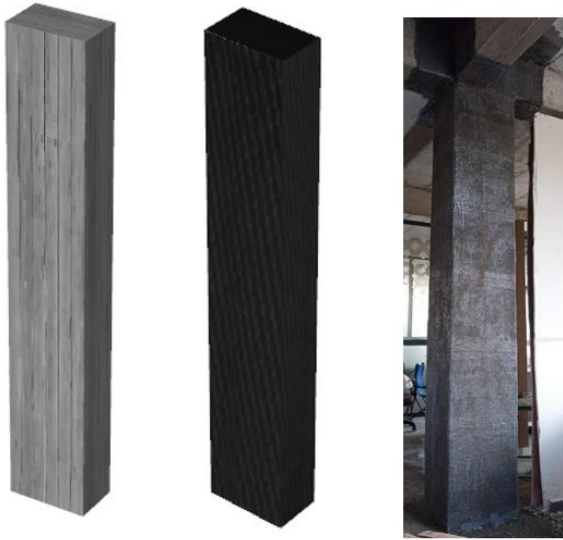
In the reference building model, columns with exceeded shear force capacity were strengthened using fibrous polymers. All columns on the first floor and four columns on the second floor were reinforced with fibrous polymer. While applying the fibrous polymer, continuous fibre application was considered without leaving any gaps along the column height. The pre-reinforcement and post-reinforcement views of the columns considered in the study and an application example are shown in Fig. 10. The numerical analyses were performed for each fibrous polymer, respectively. Fibrous polymers were consistently included in the analyses as a single layer. The diameter of the rounded corners of the fibres was taken into account as 40 mm. No anchoring is considered at the corners. These properties have not changed for different FRPs. No changes were made to the concrete and reinforcement conditions while applying FRP reinforcement to the existing structural model.

**Fig. 10.** Before/after reinforcement and application example
